Technical Report REMR-CS-63
September 1999

Repair, Evaluation, Maintenance, and Rehabilitation Research Program

Repair and Rehabilitation of Dams: Case Studies

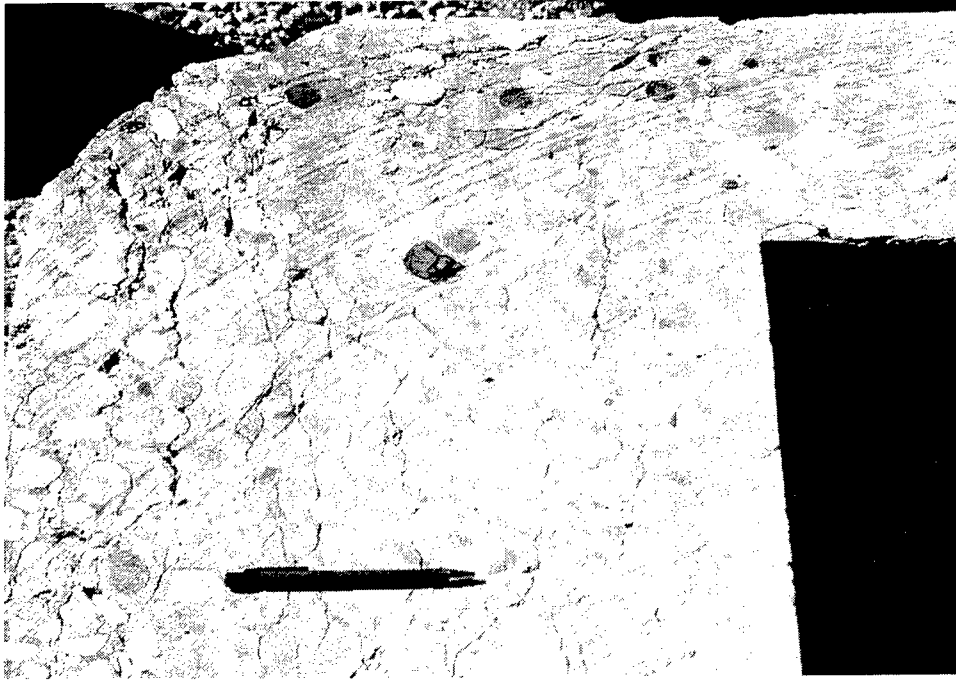
At the time of the Tenth Periodic Inspection (USAED, St. Louis 1997), the removal and replacement of columns on six of the eight bridge piers approved in the 1993 Major Rehabilitation Report were underway. Two of the columns that support the service bridge at Pier 16 had been removed. The periodic inspection team examined them and found excessive cracking, especially toward the top of the columns (Figure 8a). Generally, the concrete in the columns was in poor condition (Figure 8b).

- a. Interior cracking in concrete on Pier 11 removed for replacement, Mississippi Lock and Dam No. 24 (from U.S. Army Engineer District, St. Louis 1997)

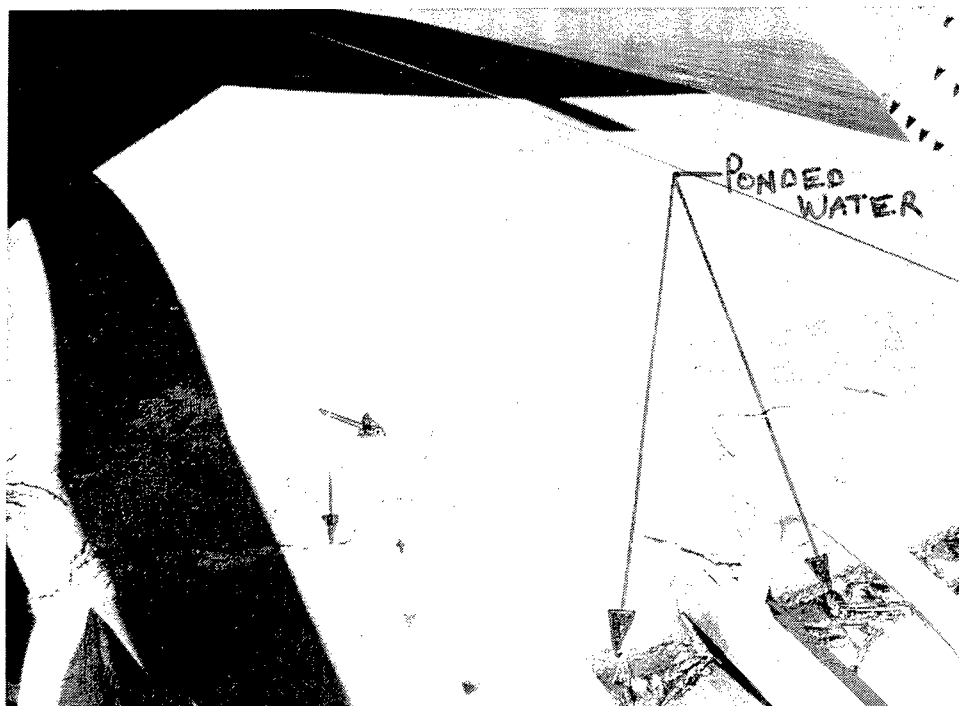
Figure 8c. Lower area of Pier 9 to be capped with floating concrete slab, Lock and Dam No. 24, Mississippi River (from U.S. Army Engineer District, St. Louis 1997)

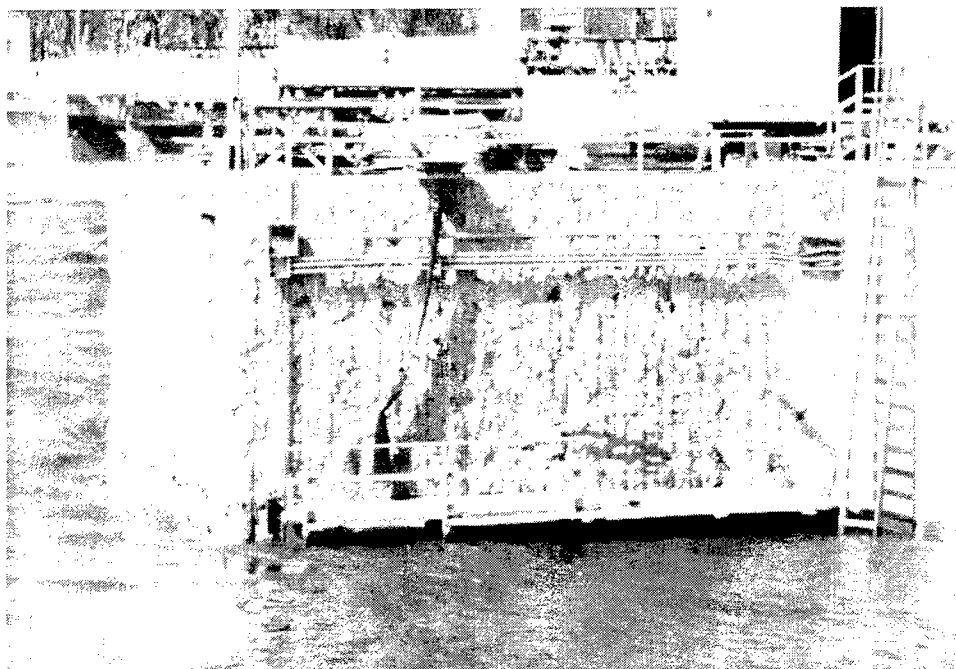
Figure 20. Concrete removal and anchors for the arch dam at Dresden Island Lock and Dam

The procedure for resurfacing the arch dam was similar to that used for the tainter gate section. Concrete removal on the arch section varied from 229 mm to 0.38 m (9 in. to 1 ft 3 in.). Line drilling, expansive grout, and chipping hammers were used to remove the deteriorated concrete (Figure 20). The arch dam after rehabilitation has been completed is shown in Figure 21.

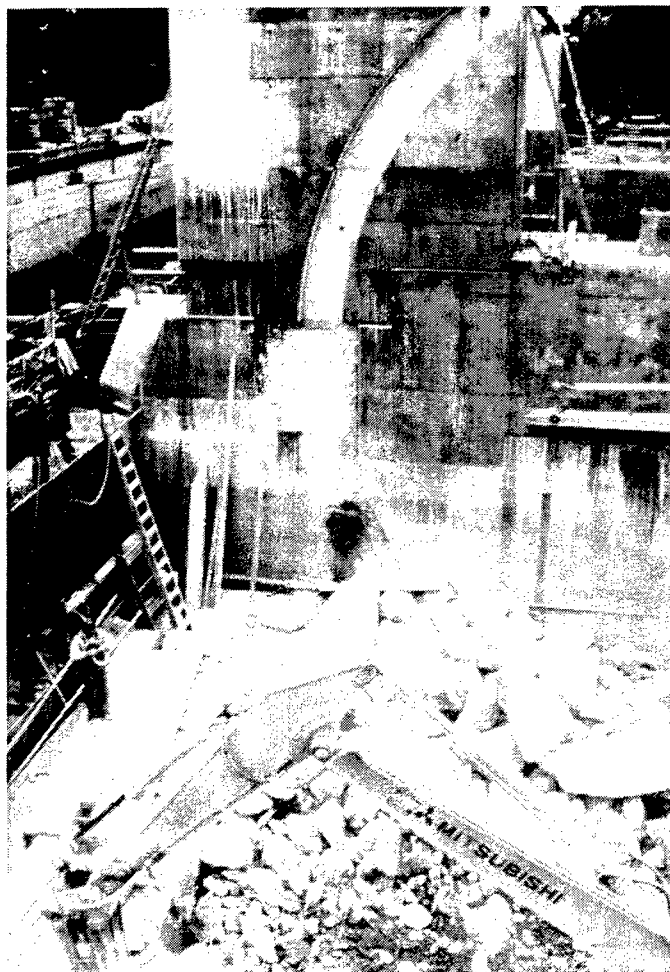
Figure 29. Concrete removal of ogee crest and side of pier to accomodate new gate, Marseilles Dam

Before the new submersible tainter gates could be installed, the piers had to be repaired and modified and the gate sills reconstructed. The ogee crest was removed and some concrete was removed from the side of the pier to accommodate the new gate (Figure 29). Concrete repair consisted of removing the deteriorated nonair-entrained concrete and replacing it with conventional reinforced mass concrete. In addition to visual inspection, concrete in the piers was further evaluated by coring. Concrete cores revealed that deterioration ranged

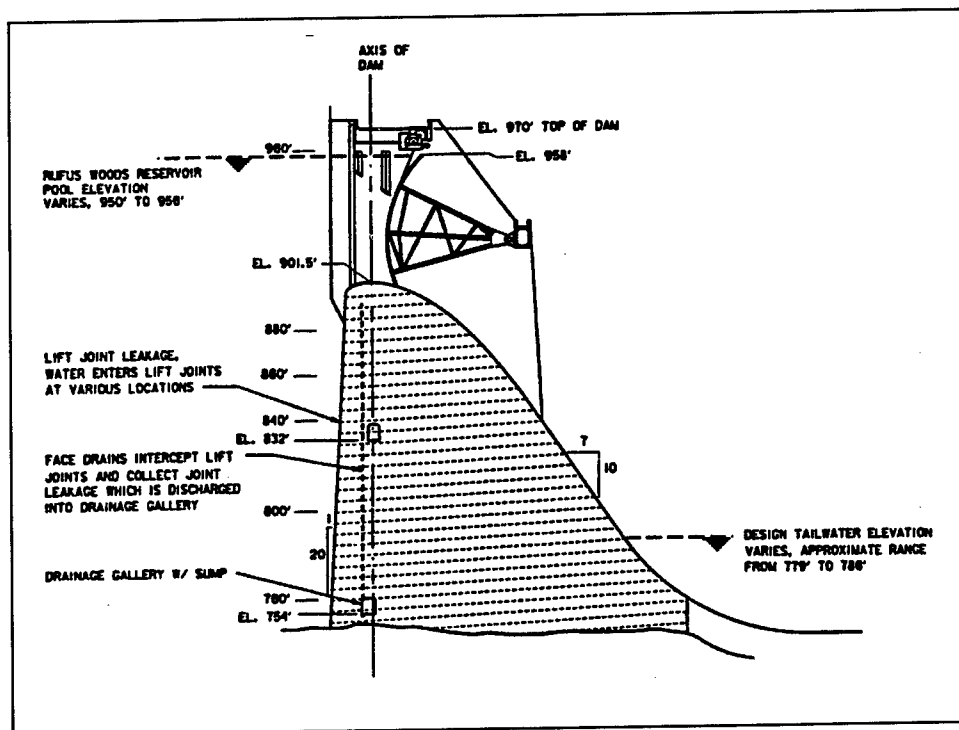
Figure 45. Monolith section showing leakage, Chief Joseph Dam (from Sondergard 1991a) (multiply feet by 0.3048 to obtain meters)

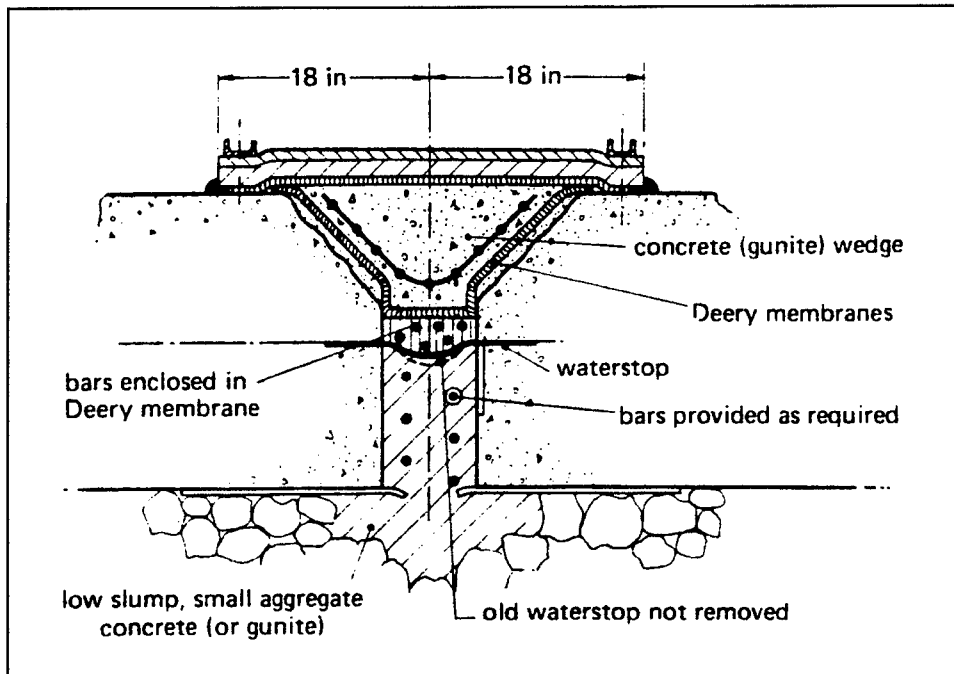
Figure 47. Details of repair for open, leaking joints at New Exchequer Dam (from Brown and Kneitz 1987)

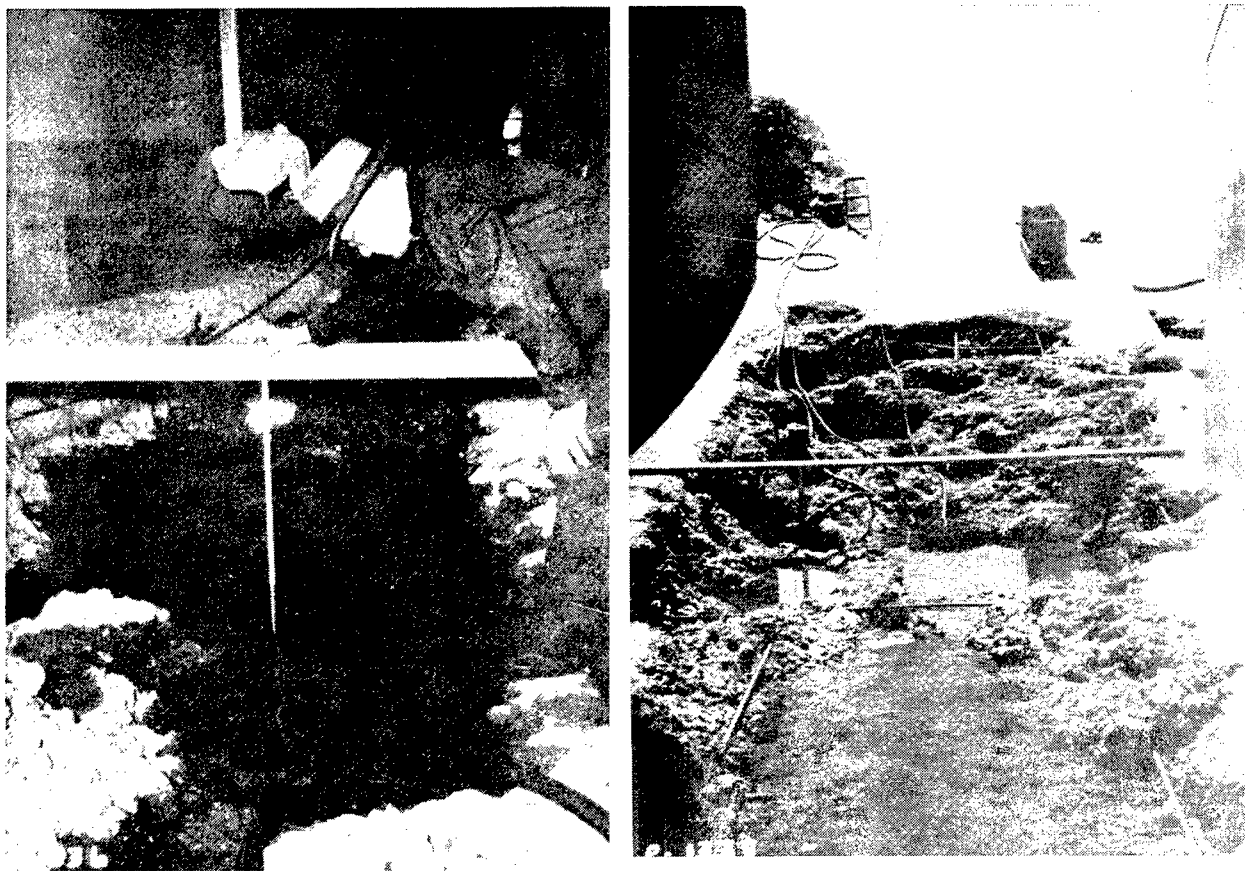
Figure 50. Upstream (left) and downstream views of cavitation in flip-bucket floor in channel no. 1, Luck Peak Dam (from U.S. Army Engineer District, Walla Walla 1983)

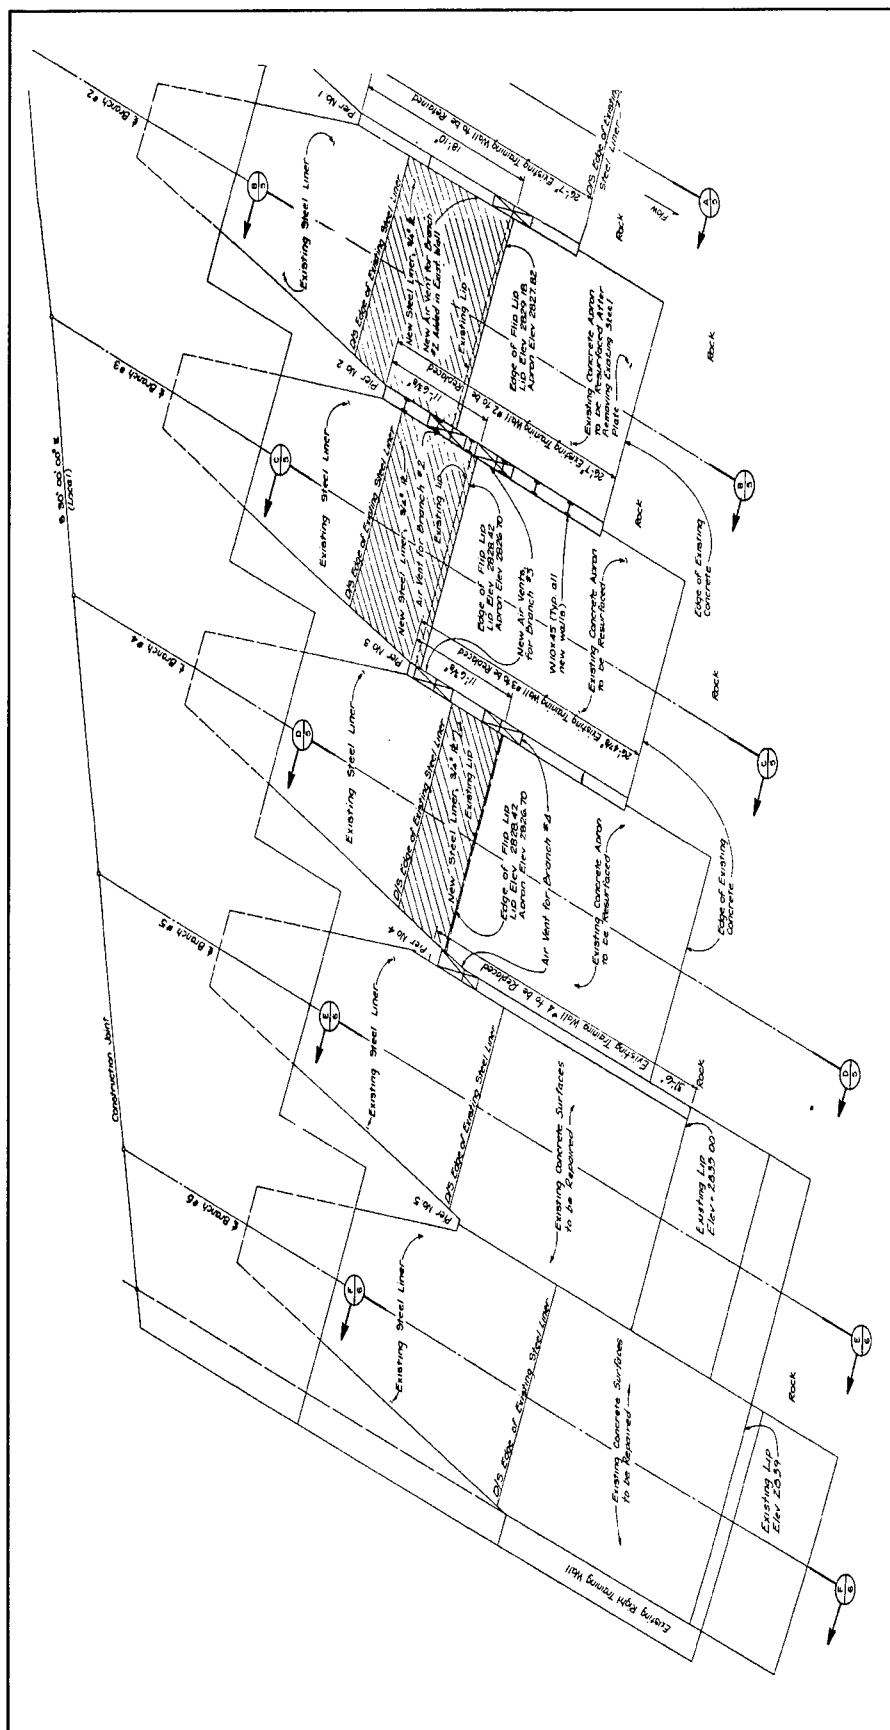
Figure 53. Plan for repairing outlet works, Lucky Peak Dam (from U.S. Army Engineer District, Walla Walla 1983)

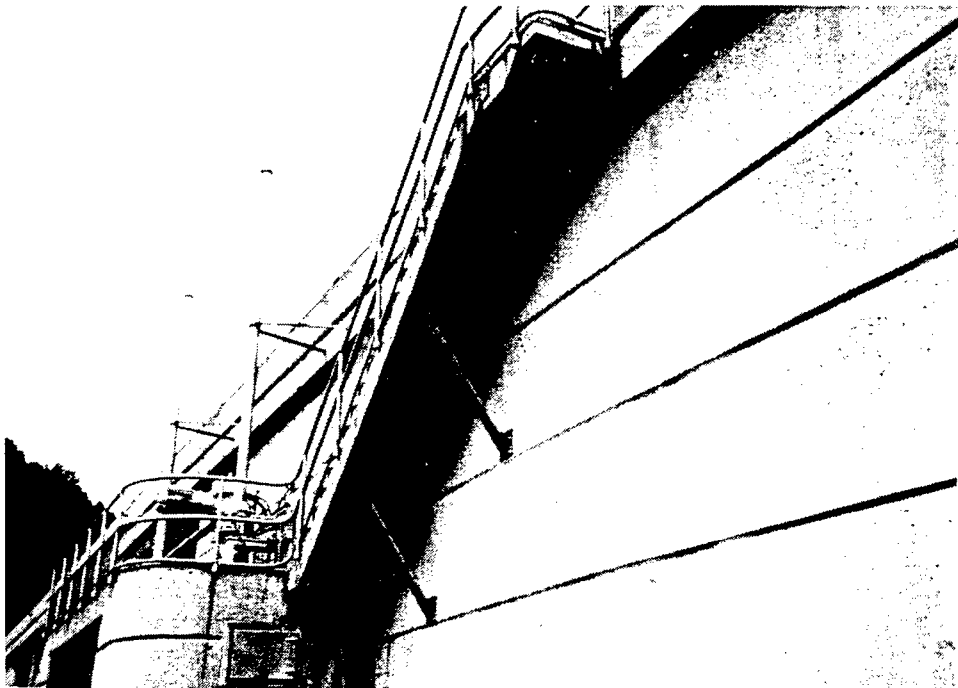
Figure 79. Stainless steel brackets installed to support water quality tower stairway, Stonewall Jackson Dam (from U.S. Army Engineer District, Pittsburgh 1992)

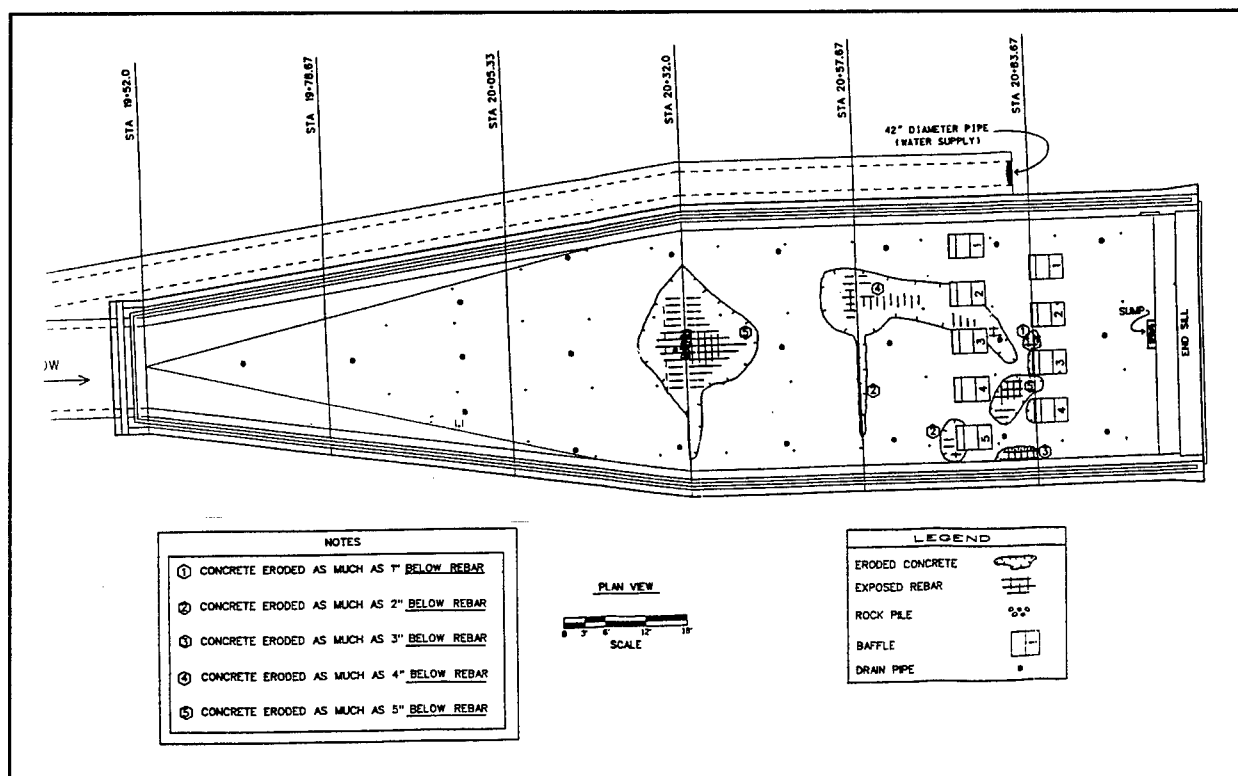
Figure 84. Condition of stilling basin at DeQueen Dam 1993 (from U.S. Army Engineer District, Little Rock 1997a)

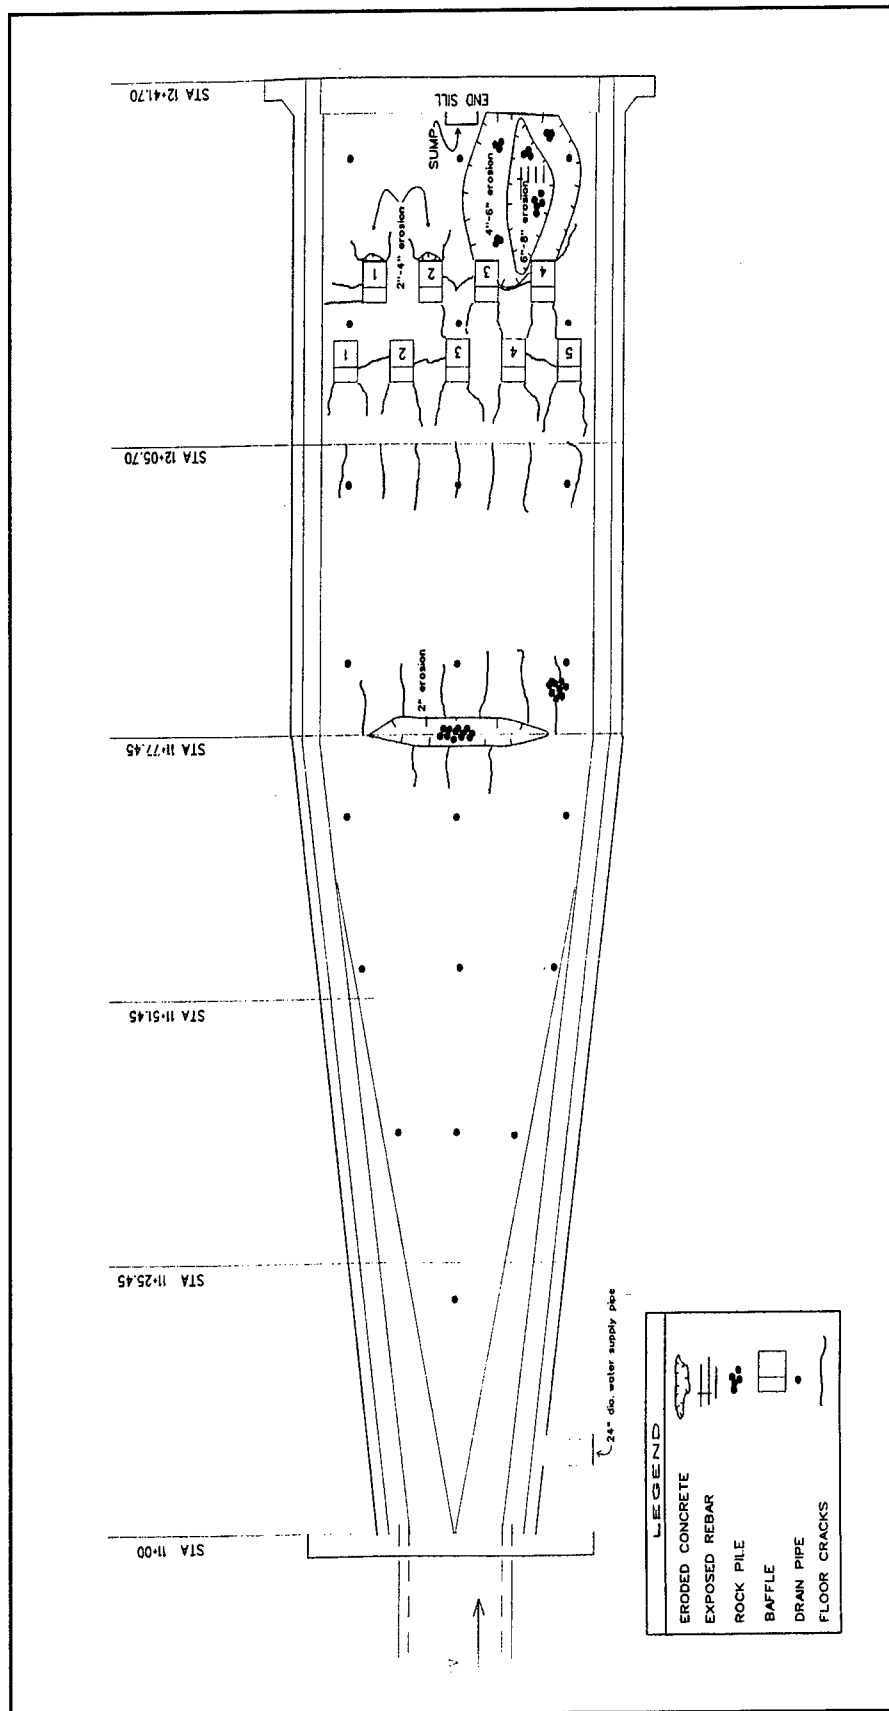
Figure 85. Erosion damage in stilling basin, Gilliam Lake Dam (from U.S. Army Engineer District, Little Rock 1997b)

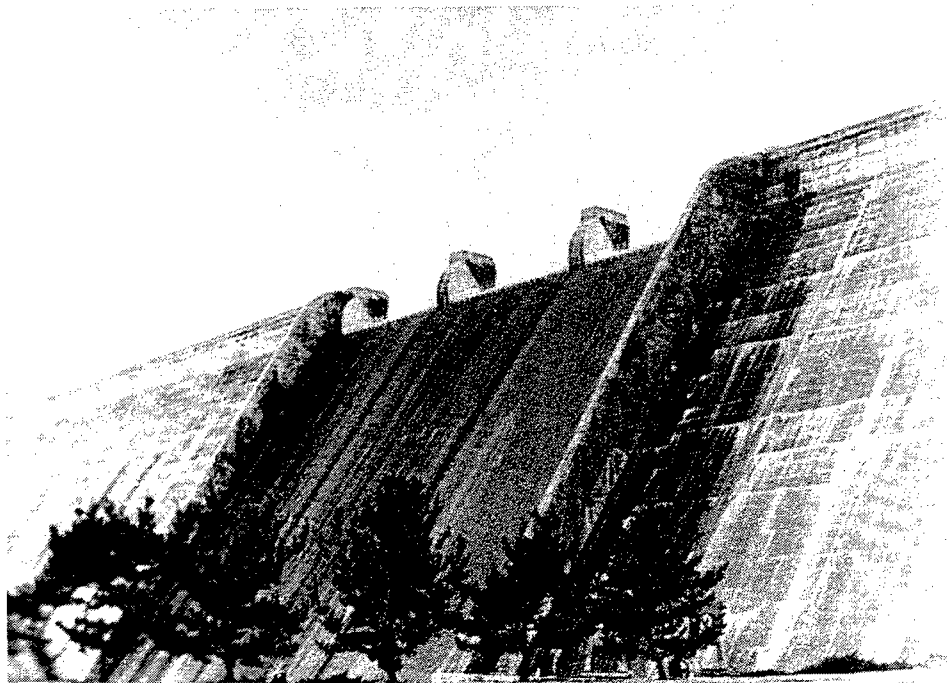
Figure 90. Alkali-aggregate extrusion on the downstream face of Friant Dam
(from *Hydro Power and Dams* 1997)

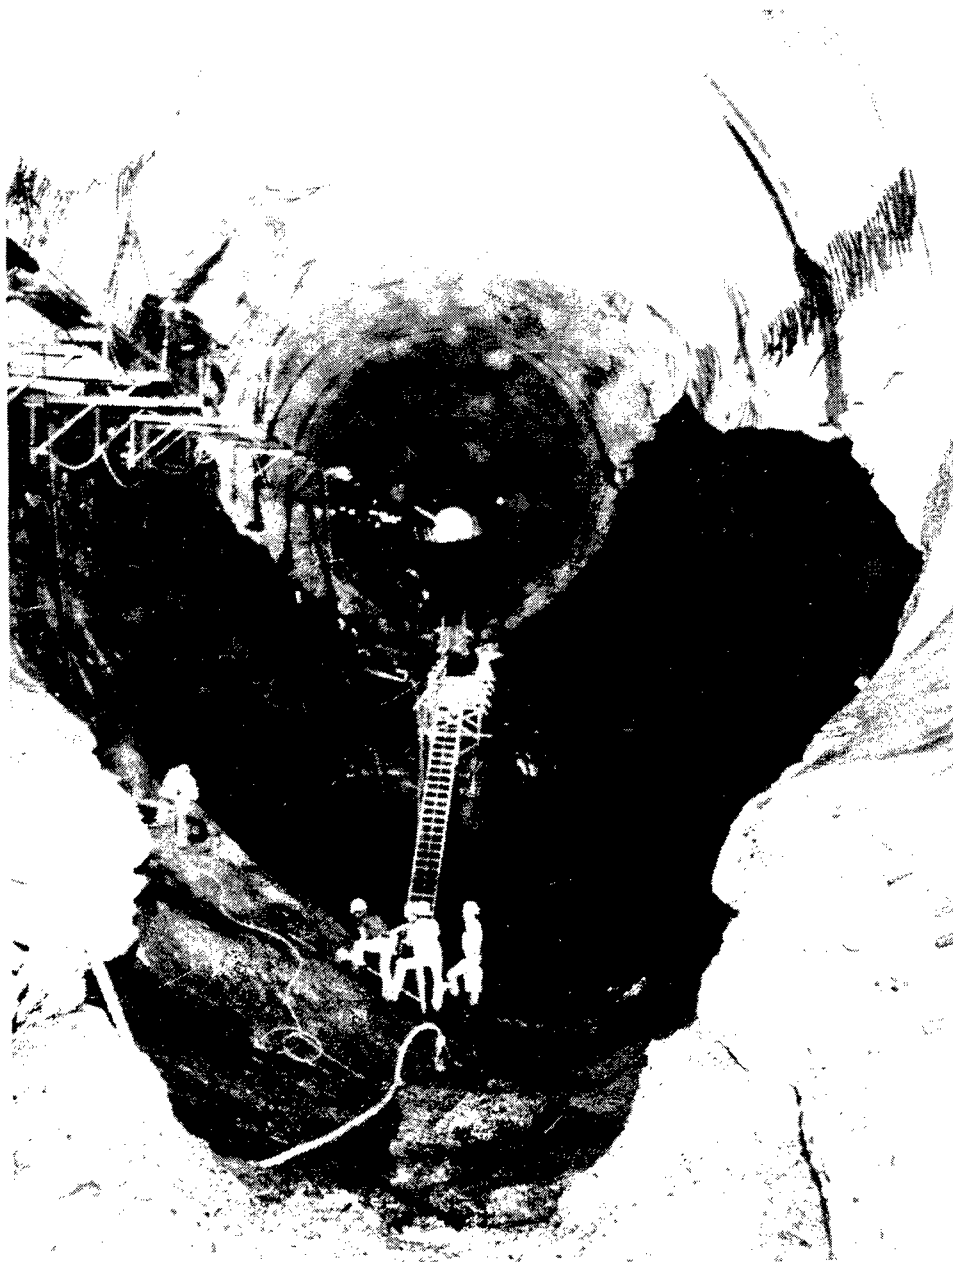
Figure 93. Cavitation damage downstream of the elbow in the left spillway elbow at Glen Canyon (from Burgi and Eckley 1987)

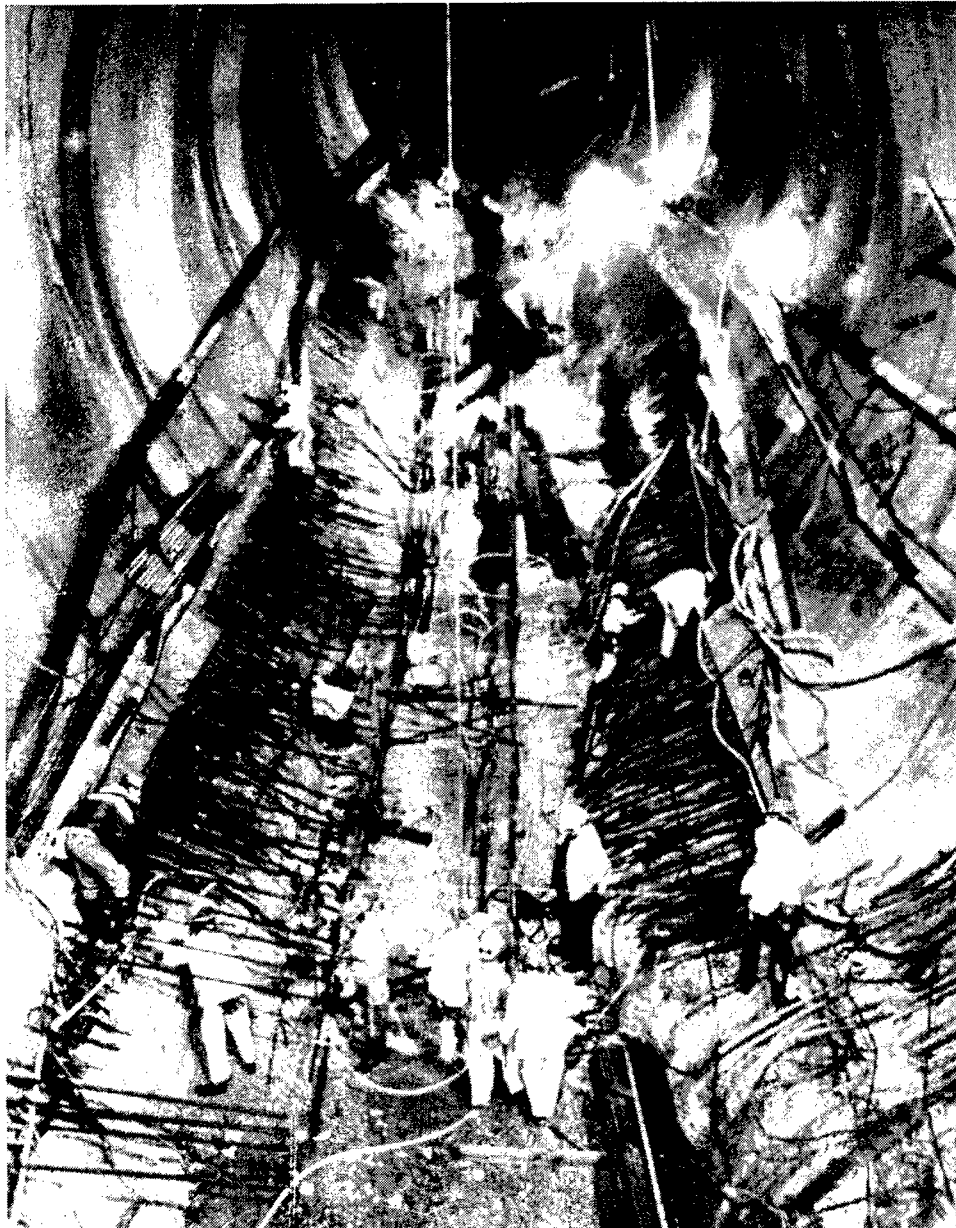
Figure 94. Steel reinforcing steel being replaced in the invert of the spillway elbow at Glen Canyon (from Burgi and Eckley 1987)

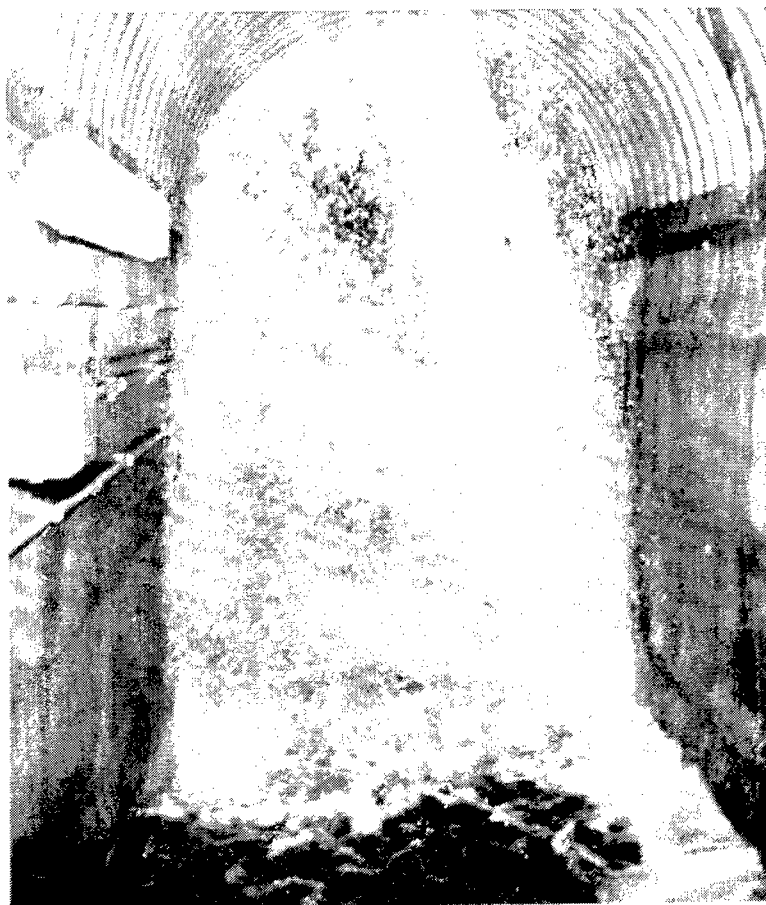
Figure 106. Leakage into the foundation gallery at Upper Stillwater Dam (from Smoak 1991)

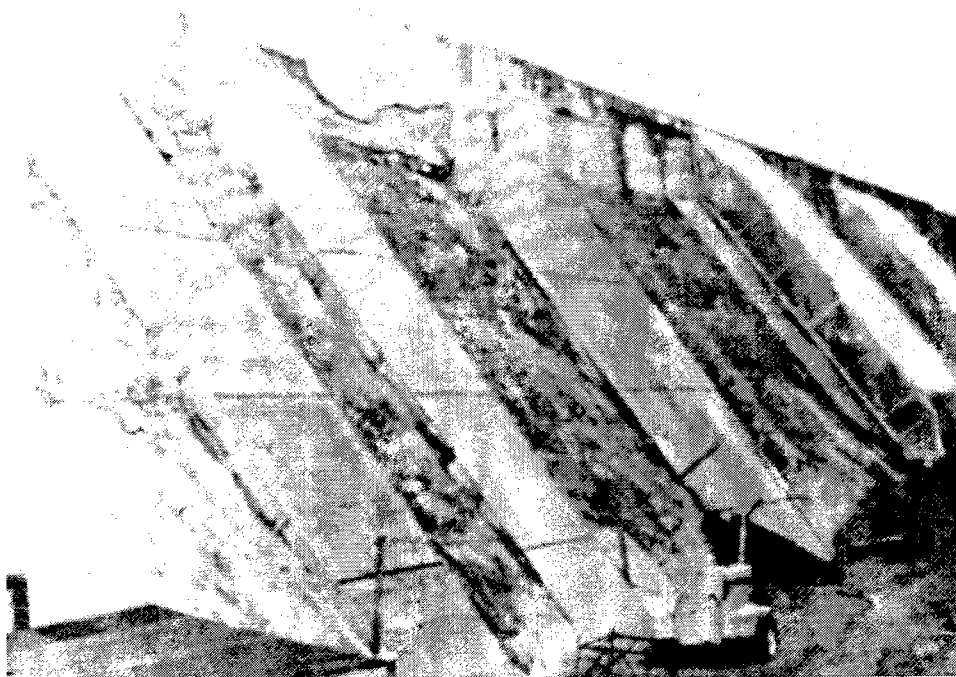
Figure 128. Repair work underway on downstream face of Hoist Dam (from Mass and Mier 1980)

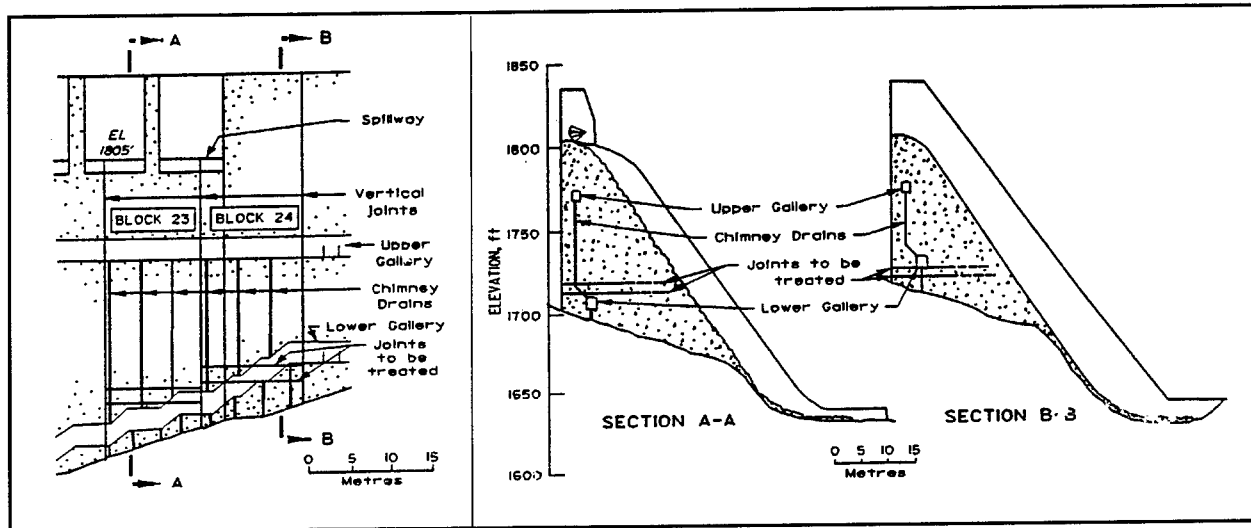
Figure 144. Investigation and treatment plan for horizontal joints in Blocks 23 and 24 at Santeetlah Dam (from Bruce 1989)

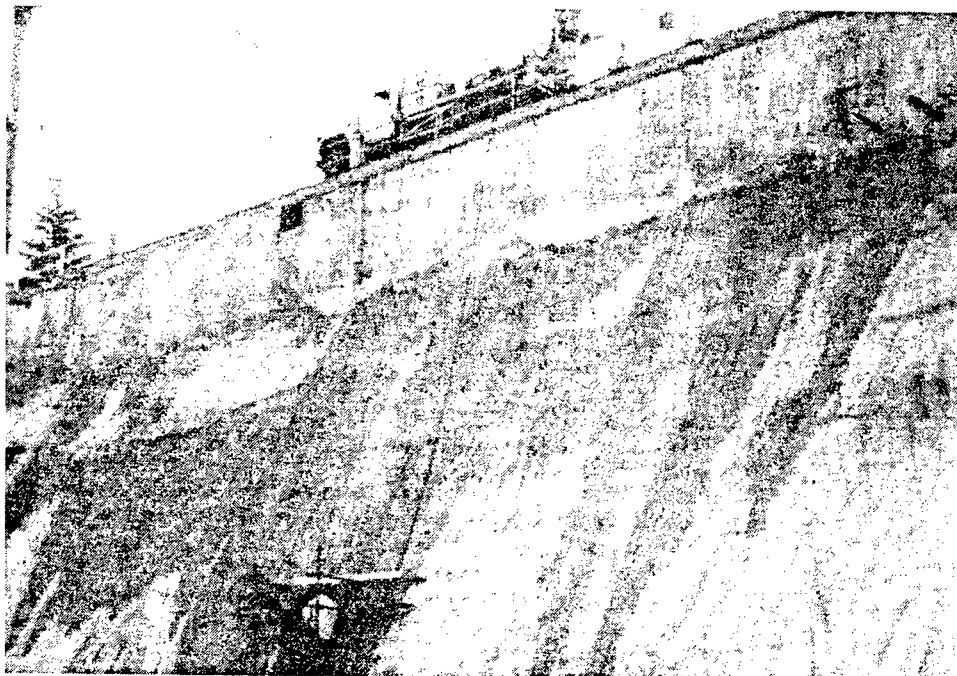
Figure 152. Seepage on downstream face of gravity section of Soda Dam (from Marold, Koniarski, and Bruen 1992)
